The guaranteed murogeopietra installation solution on EPS preserves the solidity of the façade.

The new LEPİR II test confirms that the **murogeopietra** solution on **EPS** fully complies with fire safety standards for buildings.

**CSTB - LEPİR 2 - Propagation of fire outside façades for buildings subject to specific regulations (residential buildings, public buildings, tower blocks) - FRANCE August 2018**

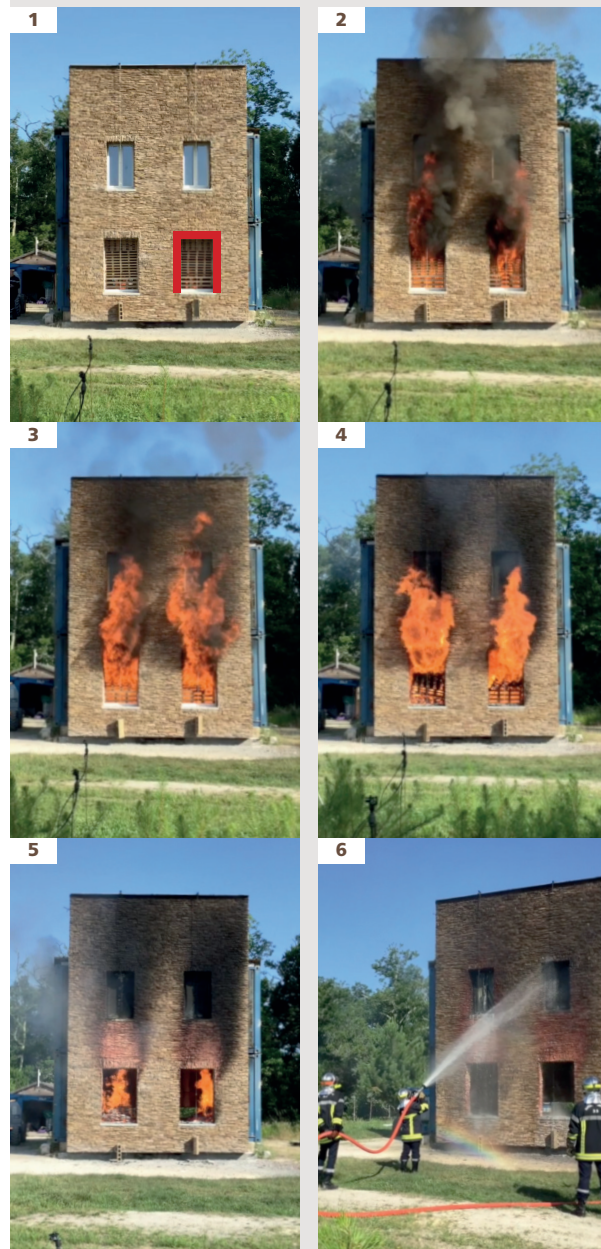
#### MUROGEOPIETRA ON EPS BEHAVIOR AT FIRE.

1. The fire sources are lit and the initial fumes are released. Right side has rock wool reinforcement above the window.
2. After 1 minute 20 seconds the flames are already engulfing 3/4 of the windows on the upper floor.
3. After 5 minutes the temperature of the façade reaches approximately 800 °C and on the left side (with no rock wool protection) the glazing on the upper floor starts breaking.
4. After 8 minutes the façade reaches the maximum temperature of approximately 1100 °C and flames engulf the left window jambs.
5. After an hour, when all the fire source fuel has been used, it can be observed that the façade has not collapsed or yielded.
6. The fire fighters use strong jets of water to put out the fire, creating considerable thermal shock on the wall, but even when persisting on areas most stressed by the test, no collapse is observed.

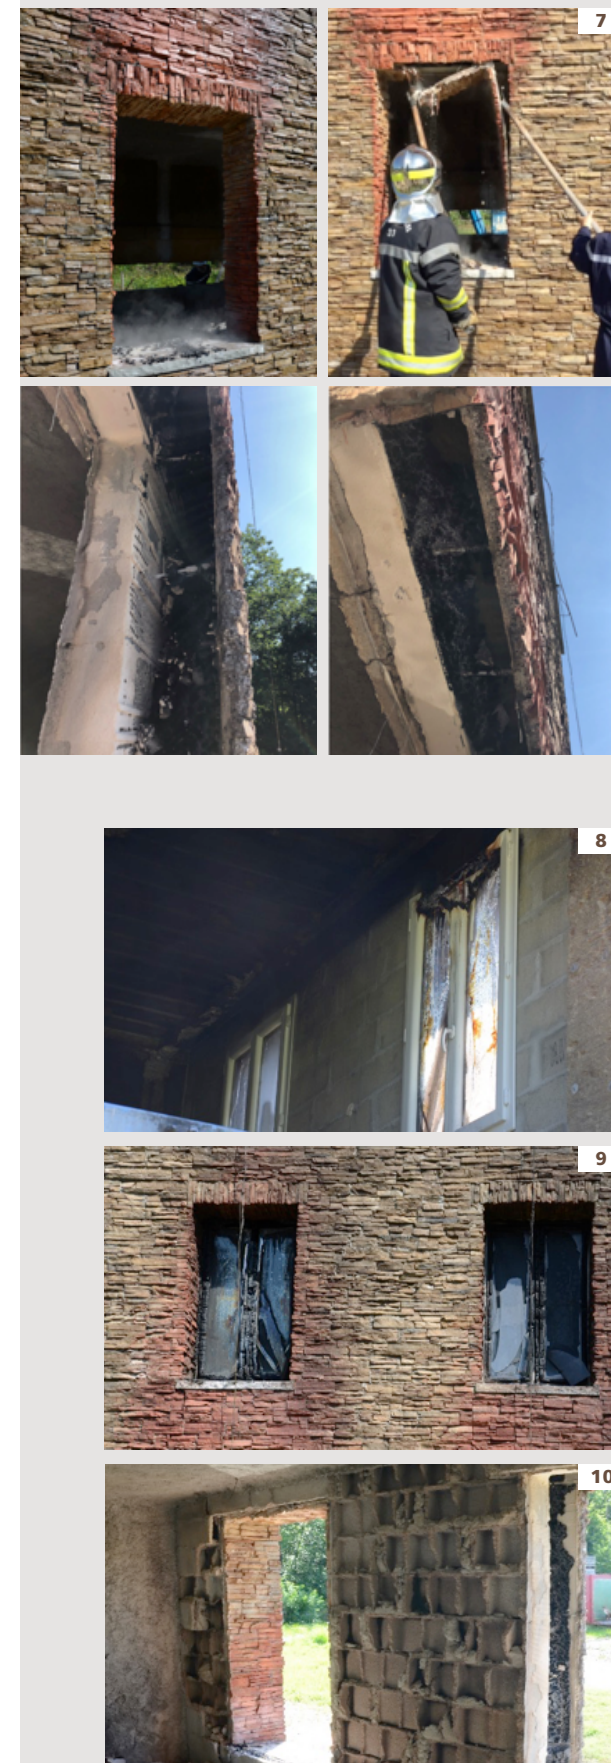
#### Visual inspection after completing the test.

7. The stone cladding was difficult to remove from the left window jamb and architrave. At the crack created through the thermal shock, it can be noted that in the absence of the panel of rock wool, the underlying EPS insulation has sublimed, whereas the guaranteed solution (Technical Manual section 6.21) has contributed to keeping the layers of adhesive, mesh and stone perfectly anchored to the base via the wall plugs.

8. The barrier effect of the rock wool panel was significant in triggering a protective reaction against the flames on the wall, reducing the temperature and preventing the flames from engulfing the frames on the upper floor.

9. The PVC frame on the left window was unable to withstand the fire, allowing the flames to spread inside. Although the right window frame was ruined it withstood the fire, remaining hermetically sealed against the flames and the fumes.

10. It can be observed inside that the cellular cement bricks in the room where the fire propagated literally exploded due to the excessive heat.
